# WARFIGHTER SUPPORT

## Independent Expert Assessment of Army Body Armor Test Results and Procedures Needed Before Fielding

Highlights of [GAO-10-119](#), a report to congressional requesters

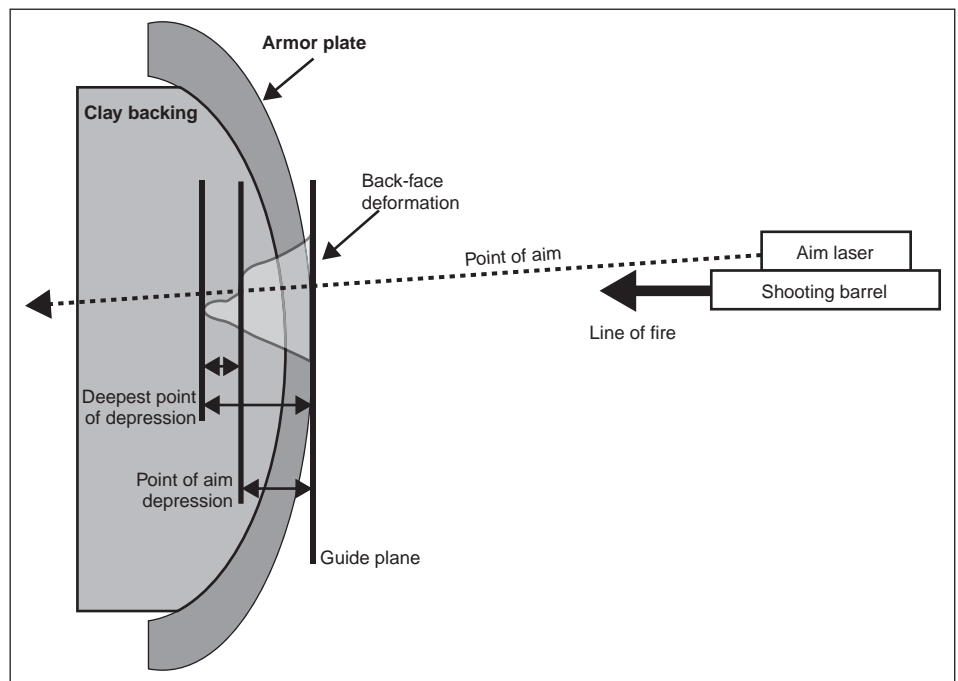
During Preliminary Design Model testing the Army took significant steps to run a controlled test and maintain consistency throughout the process, but the Army did not always follow established testing protocols and, as a result, did not achieve its intended test objective of determining as a basis for awarding contracts which designs met performance requirements. In the most consequential of the Army's deviations from testing protocols, the Army testers incorrectly measured the amount of force absorbed by the plate designs by measuring back-face deformation in the clay backing at the point of aim rather than at the deepest point of depression. The graphic below depicts the difference between the point of aim and the deepest point.

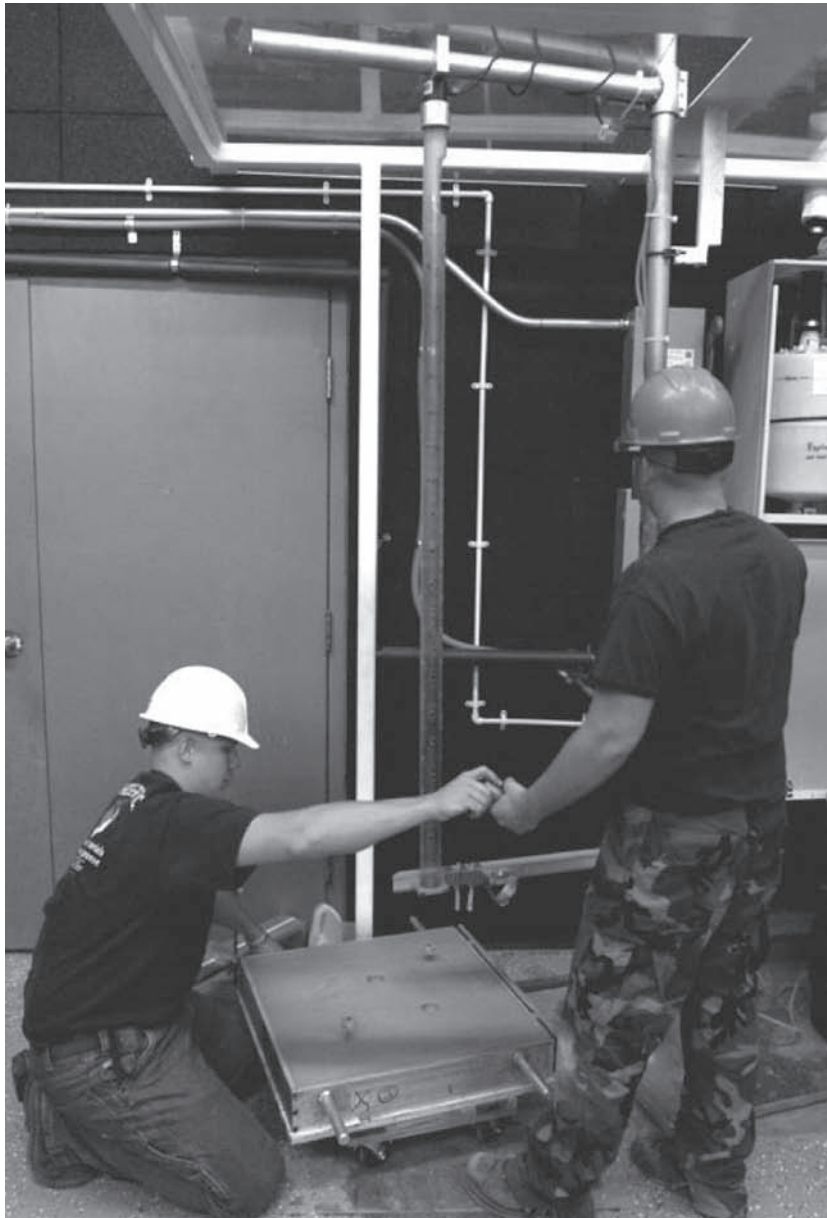
**Figure 3: Clay Being Calibrated with Pre-Test Drops**

Of potentially greater consequence to the final test results is our observation of deviations from testing protocols regarding the clay calibration tests. According to testing protocols, the calibration of the clay backing material was supposed to be accomplished through a series of pre-test drops.<sup>26</sup> The depths of the pre-test drops should have been between 22 and 28 millimeters. Aberdeen Test Center officials told us that during Preliminary Design Model testing they did not follow a consistent system to determine if the clay was conditioned correctly. According to Aberdeen Test Center officials, in cases in which pre-test drops were outside the 22- to 28-millimeter range, testers would sometimes repeat one or all of the drops until the results were within range—thus resulting in the use of clay backing materials that should have been deemed unacceptable for use. These inconsistencies occurred because Army testers in each test lane made their own, sometimes incorrect, interpretation of the testing protocols. Members of the Integrated Product Team expressed concerns about these inconsistencies after they found out how calibrations were being conducted. In our conversations with Army and private body armor testing officials, consistent treatment and testing of clay was identified as critical to ensure consistent, accurate testing. According to those officials if the clay is not conditioned correctly it will impact the test results. Given that clay was used during Preliminary Design Model testing that failed the clay calibration tests, it is possible that some shots may have been taken under test conditions different than those stated in the testing protocols, potentially impacting test results. Figure 3 shows an Army tester calibrating the clay with pre-test drops.

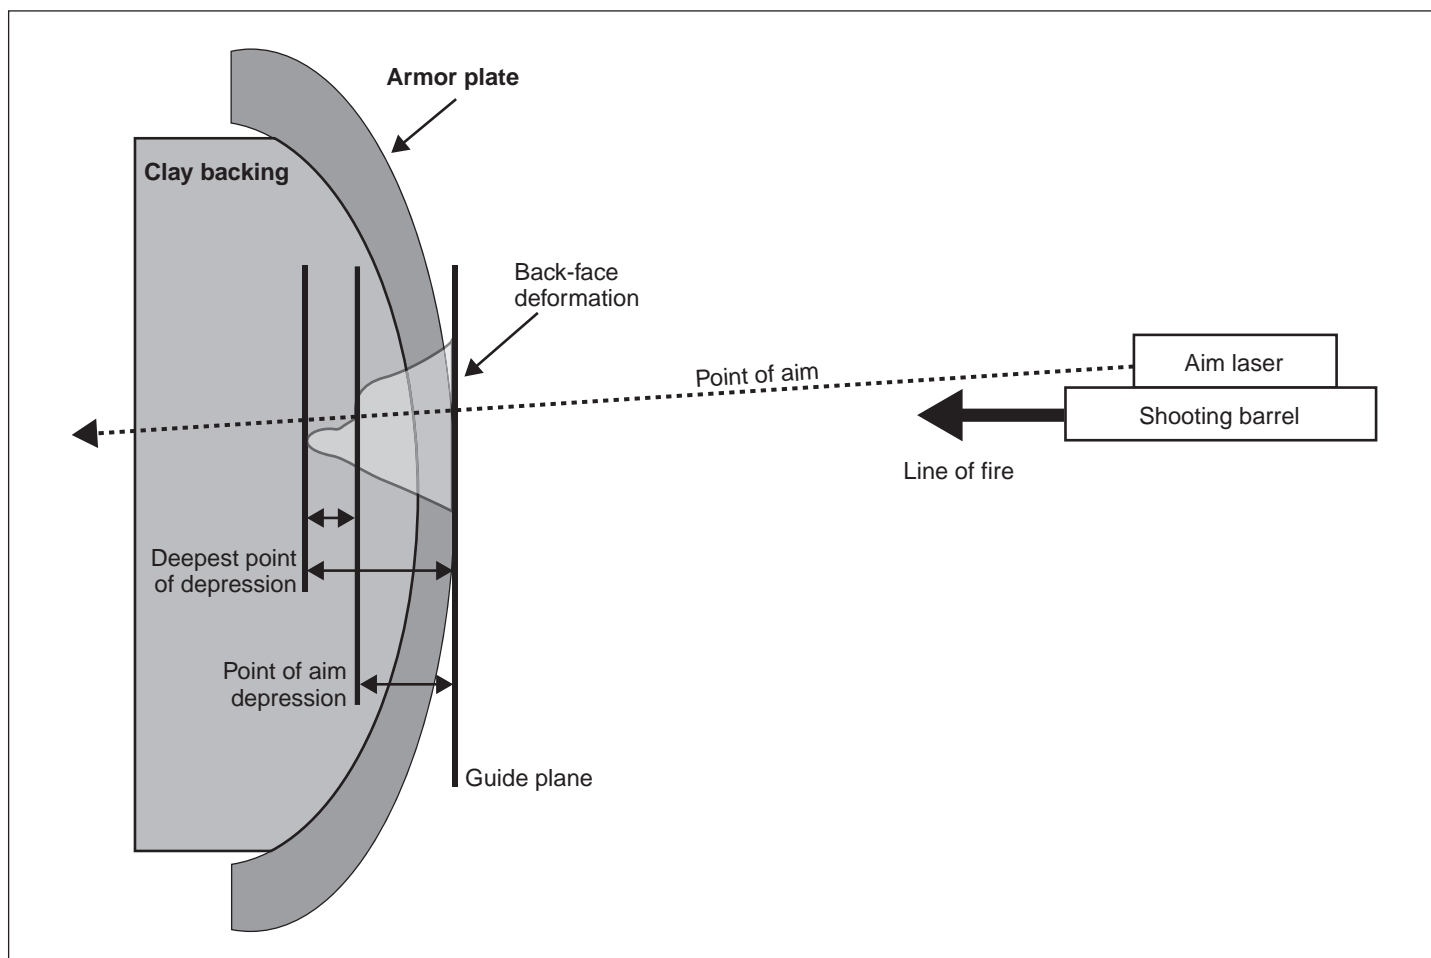
**Figure 4: Graphic Representation of the Difference between the Point of Aim and the Deepest Point**

The most consequential of the deviations from testing protocols we observed involved the measurement of back-face deformation, which did affect final test results. According to testing protocol, back-face

When members of the Integrated Product Team overseeing the testing were made aware of this error, the Integrated Product Team decided to begin measuring at the deepest point of depression. When senior Army leadership was made aware of this error, testing was halted for 2 weeks while Army leadership considered the situation. Army leadership developed many courses of action, including restarting the entire Preliminary Design Model testing with new armor plate submissions, but ultimately decided to continue measuring and scoring officially at the point of aim, since this would not disadvantage any vendors. The Army then changed the test plans and modified the contract solicitation to call for measuring at the point of aim. The Army also decided to collect deepest point of depression measurements for all shots from that point forward, but only as a government reference. During the second two-thirds of testing, we observed significant differences between the measurements taken at the point of aim and those taken at the deepest point, as much as a 10-millimeter difference between measurements. As a result, at least two of the eight designs that passed Preliminary Design Model testing and were awarded contracts would have failed if the deepest point of depression measurement had been used. Figures 4 and 5 illustrate the difference between the point of aim and the deepest point.

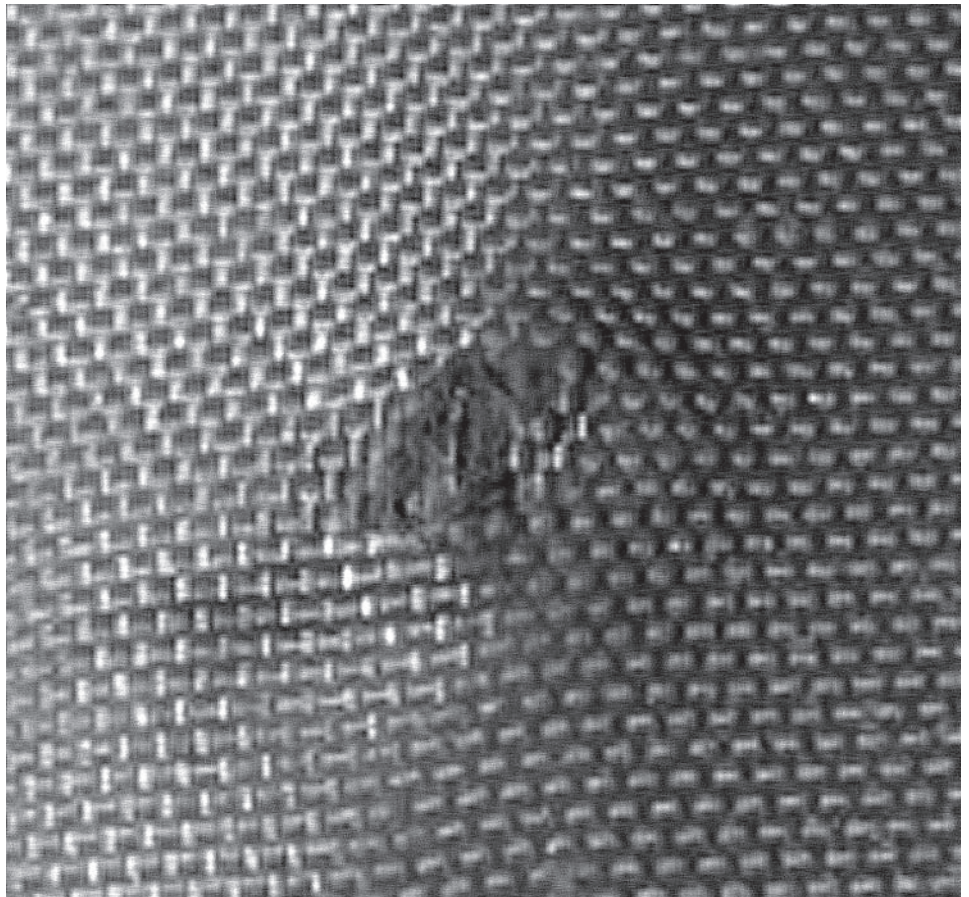
**Figure 6: Tears in Kevlar Backing Material after a Penetration of the Plate**

During First Article Testing, Army testers deviated from the established testing protocols by improperly scoring a complete penetration as a partial penetration. Army testers said they used a method to evaluate the penetration results that was discussed internally before First Article Testing but that was not described in the testing protocols or otherwise documented. As a result of this incident, one design passed First Article Testing that would have otherwise failed.<sup>11</sup> With respect to internal control issues, the Army did not consistently maintain adequate internal controls to ensure the integrity and reliability of test data. In one example, during ballistic testing, data were lost and testing had to be repeated because an

**Response:** This information appends that provided in the earlier discussion of this issue. While Figure 6 of the GAO report appears to show evidence of a perforation on the rear of the test plate in question, by the definition in the Purchase Description, a complete perforation is scored based upon the damage to the soft armor shoot pack directly behind the ballistic test plate. The front (face immediately behind the plate under test) of the shoot pack in question is shown in Figure 6 of this response, located below. Though deformed, the damage does not constitute a complete perforation of the plate according to the definition in the Purchase Description.

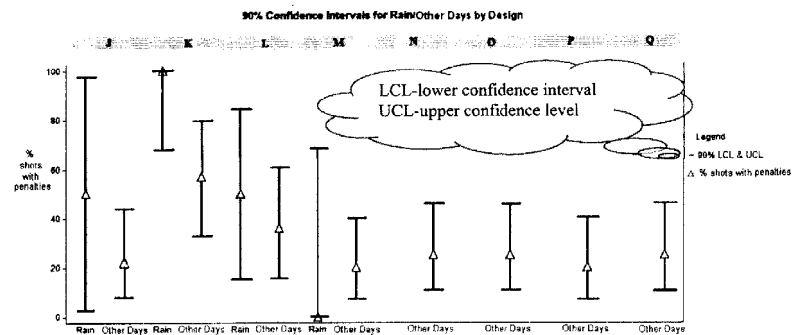
ATC analysis also shows that the poor performance of the vendor's design in question was attributed to its marginal performance against the most formidable threat round under test, not to a brief time (seconds) of exposure to a “constant heavy, cold rain and low temperatures” or the effects of rain on the clay surface. Statistical analyses were performed on the test results for all designs including those tested on November 13, 2008. The result of that analysis, as shown in Figure 5, indicate Design K was the weakest

design on days with no rain as well as days with rain. Design K had a 70 percent failure rate during all testing against the most formidable threat. Even when excluding the rain day data, which was when that design was subjected to the most stressing tests, the design still had a 57 percent failure rate.

Figure 5. Results of ATC analysis of test results for all vendor designs against the most formidable threat.

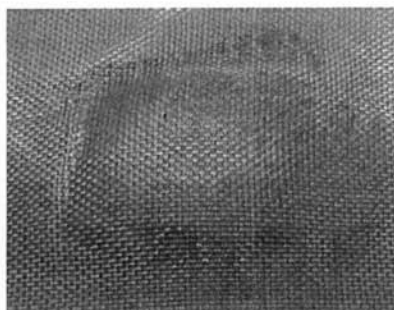
Figure 6. Front face of shoot pack for the test in question.
